## Qualitative Analysis of Urban Tree Arborization in the Streets of São Carlos (São Paulo/Brazil)

**ABSTRACT:** Tree arborization in streets brings several advantages to the urban environment. In addition to their aesthetic function, urban trees cool local surface temperature, provide air humidity, ensure shelter and food for birds, reduce soil erosion while providing shade, all of which results in a more enjoyable urban landscape. Due to the city's dynamism and growth demands, urban streets often lack good tree coverage on the sidewalks or central plant beds along the streets. This paper conducts a qualitative study on tree arborization in seven public streets located in the urban area of São Carlos (São Paulo/Brazil). These streets were selected because of their high traffic flow. The methodology used in this research consists of an in loco qualitative analysis of urban trees using the Geographic Information System (GIS) to contextualize the road sections under study. The results showed the occurrence of species diversity, development stages, and the level of care and maintenance of trees along the streets assessed. The potential for inserting new arboreal specimens was also ob

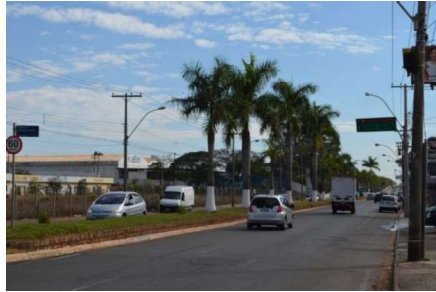
**Relevant aspects:** This Avenue has a narrow plant bed with palm trees along its entire length (1.5 meters wide by 0.4 meters high). This street has no elaborate landscaping. Figure 3 shows the beginning of this avenue.

**Problems encountered:** The structure of the plant bed, 1.5 meters wide and 0.4 meters high, is an obstacle for pedestrian traffic. The sidewalks of this Avenue were not planned to include afforestation of dicotyledonous species. The sidewalk indentation between the retail establishments and the street has discrepancies, and with rare exceptions in some of these establishments there are trees of other species, all medium size, at most.

Figure 3. Partial view of Getúlio Vargas Avenue

There is significant difference between some of streets studied, such as 1 and 7 (Figures 3 and 9, respectively), considering the focus of this discussion addresses the central plant bed and its afforestation. Street 1, with palm trees planted along its length and a central plant bed of 1.5 meter wide (and 0.4 meters tall), obstructs pedestrian traffic and includes mostly monocots species, which despite their beauty, do not provide sufficient shade. Street 7, which has central plant beds that are 7-meter wide, and which predominantly includes varied dicotyledonous species, known as good shade providers. There is no difference in height between the level of the pavement and the trees planted, showing consideration for pedestrians. The width of the central beds, the mix of adult dicotyledonous species, the shading, spacing and positioning of trees in Street 7 are successful examples that could be replicated in new streets.

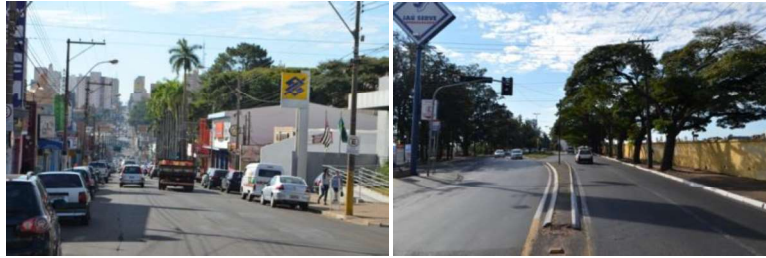
**Relevant aspects:** This is the main avenue of the city, given its connection with several other streets, although its traffic flow is not the highest (Table 1). This avenue has narrow sidewalks with streetlights and electric posts that are at times situated in the middle, demonstrating they were not adequately planned for pedestrian mobility. The urban trees along this street can be observed in the 8 squares positioned along both sides. However, this tree arborization serves the internal spaces more than the street. At the end of this avenue there are large-sized trees on the sidewalks, on both sides (Figure 4, second photo).

**Problems encountered:** This Avenue, with few exceptions, has trees due to the bordering squares. At the end of the street (near the cemetery) there is conflict with the electric wiring, the tree pruning performed that modified its design, bringing a different aesthetic to the canopies. These trees are in an undersized sidewalk for their size, evidencing its displacement in the direction of the street. In addition, in these examples a section is filled with cement, demonstrating inadequate care and maintenance. Except for the sidewalks of the squares, the other sidewalks located along this avenue were not planned for pedestrians, electric poles and trees.

Figure 4. Two different sections of São Carlos Avenue. The first picture shows the urban trees of a square. The second photo (at the end of the avenue) shows the trees trimmed because of the electric wires.

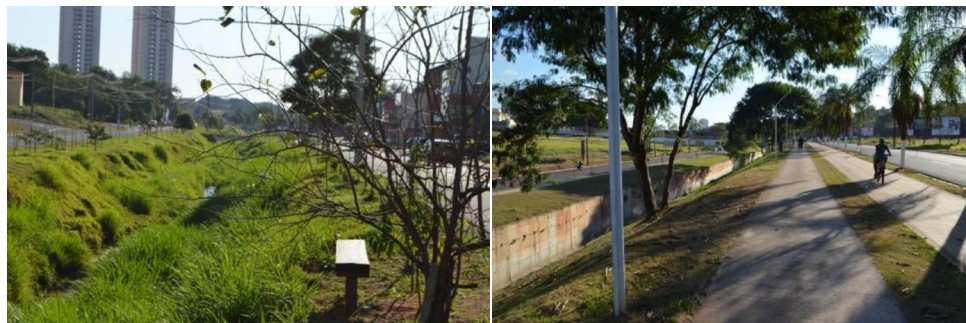
**Relevant aspects:** This Avenue shows a discontinuity in two sections, as seen in Figure 2. When referring to the first section, it is the one on the right. The avenue has a central plant bed, its width varies (4 to 35 meters) and the composition of the urban trees is varied. The green area segment accompanies the stream *Córrego do Gregório*. In the section where it passes through the city center, this stream is buffered. There was a vegetation recovery effort on the banks of the stream in the first stretch of the street (Figure 5). The avenue has a bike lane on one side of the street, but without any trees planned or aimed for this path. In the second stretch, walking paths and bicycle paths were built in the central plant bed which serve as a Permanent Preservation Area (Figure 5, on the right side), and there are also trash bins and cement benches. In this section, greater care was observed in the distribution and maintenance of the species, as well as the rest of the equipment.

**Problems encountered:** In both sections there are dead and vandalized species. Near the stream embankments there are no trees, with the occurrence of erosion and landslides during the rainfall periods. In some sections the pavement is raised due to undersized plant beds and tree species at more advanced development stages. The second section of this avenue, on the right, has pits (beds) on the sidewalks at every 20 meters for the inclusion of afforestation. However, few of these sites received plant species and many of the beds are cracked, which continues for the remaining sidewalk, prone to accidents for the pedestrians that circulate there.

Figure 5. Alfredo Maffei Avenue in the first and second section, respectively.

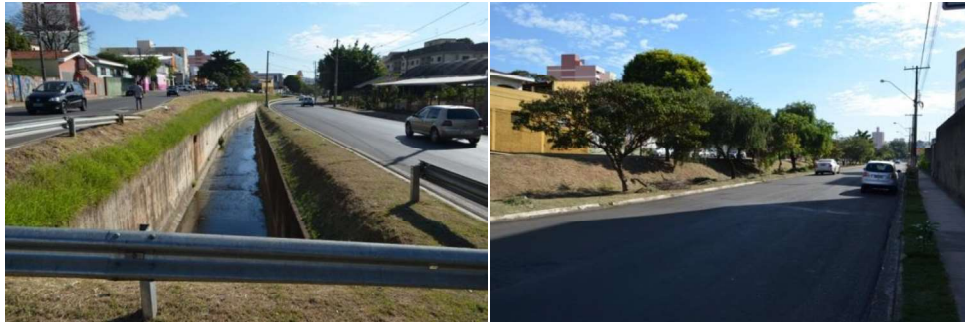
**Relevant aspects:** This Avenue follows the stream Córrego do Tijuco Preto, which was initially buffered. It has underutilized sections for afforestation (Figure 6) and the others with vegetation under development. There is no standard for local afforestation and its final section has more developed arboreal specimens (in greater numbers and variety), basically planted along the stream banks, consisting of a Permanent Preservation Area (APP).

**Problems encountered:** The first 160 meters of the Avenue, after the stream was unbuffered, could be afforested. However, this section only has grass as vegetation cover. Conflict with the electrical wiring was observed for some species.

Figure 6. Trabalhador São Carlense Avenue in the unbuffered section

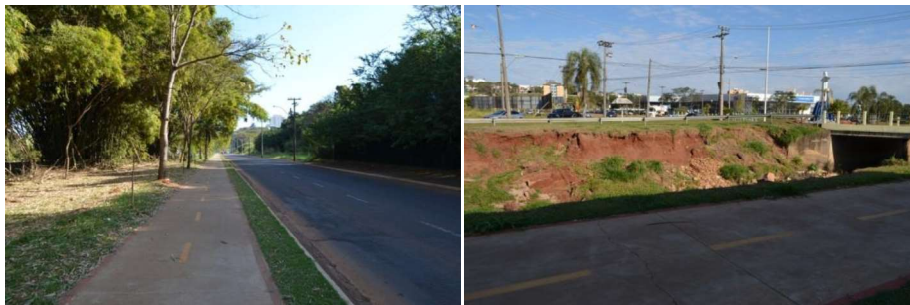
**Relevant aspects:** Along most of the Avenue there is a bike path (Figure 7) in the central plant bed that accompanies the stream Monjolinho. There are several species in early development stages along this bed. However, there are some embankment sections that deteriorated from the rains and are eroding. The avenue, on one of its sides (stretch of about 600 meters) has a bush area of about 10 hectares (Environmental Preservation Area) belonging to the municipal government. At the end of this avenue there is a roundabout and the area is underutilized for planting tree species.

**Problems encountered:** There are landslips in some sections of the Monjolinho stream. There are many non-preserved species lacking maintenance (pruning), and also the occurrence of vandalism of small trees.

Figure 7. Francisco Pereira Lopes Avenue highlighting the bike path and landslide of the slope (photo on the right)

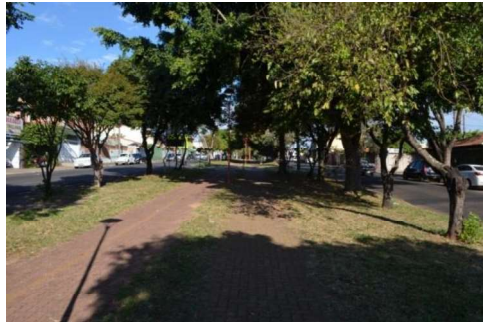
**Relevant aspects:** This Avenue has a central plant bed (10 meters wide) with a walking path, bike path (Figure (Figure 8) and equipment such as trash bins, benches and light posts. The dispersed species provide shading along the walking path. There is species diversification at different development stages. In addition to the central plant bed, there are some species distributed (less frequently) along the external sidewalks.

**Problems encountered:** low maintenance was observed at this location due to lack of cleaning and acts of vandalism (broken trash bins). Although this section has tree arborization in many parts and there is a walking path, there are unfavorable points to practice exercises due to the level of car noise and gas emissions.

Figure 8. Central plant bed along Henrique Grégori Avenue.

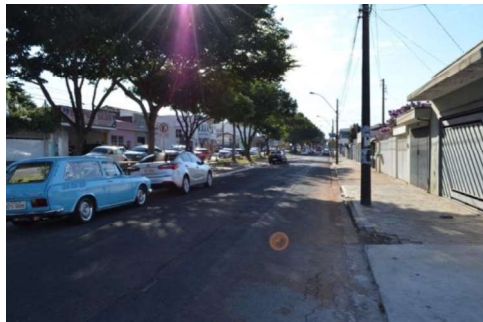
**Relevant aspects:** A central plant bed of 7 meters, equipped with pavement at both ends and large individual trees in an advanced and uniform development stages planted in the center of this bed along its length. In sections of the street, the central bed has equipment such as benches. Aside from the central bed there are no species planted on the sidewalks (Figure 9).

**Problems observed:** Few flaws but it could receive new tree species.

Figure 9. Dr. Teixeira de Barros Avenue and its central plant bed (on the left side)
