Analysis of the Bernardo Mascarenhas Cultural Complex based on the criteria of sustainable development

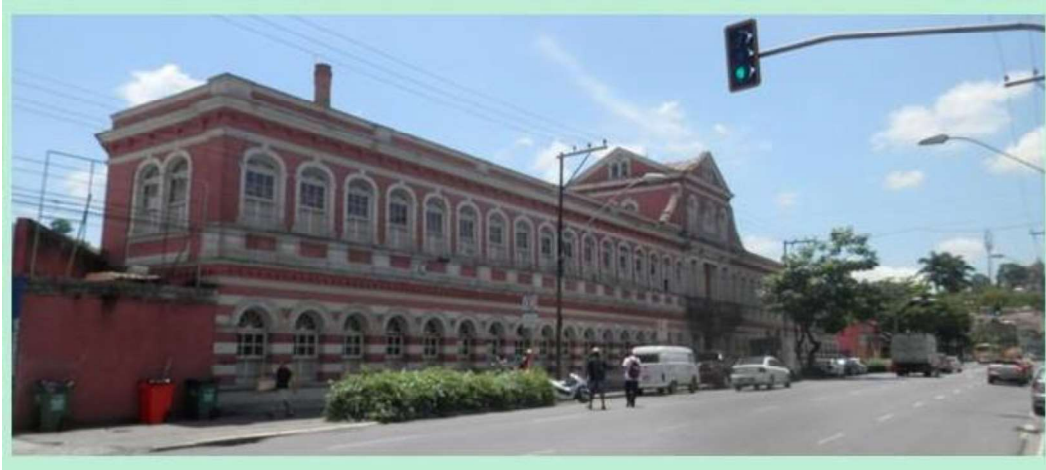
The building, which currently works as a space for art and culture, was the focus of the premises of the social movement “Mascarenhas, my love” in 1983, supported by exponents of the arts from Brazil and, in particular, from Minas Gerais (PEREIRA, 2013). The BMCC has strict symmetry (see Figure 2), with an architectural project grounded in a central body constituted by three floors. The building can be divided in two parts: the technical area and the public access area. The facades are dominated by the symmetrical rhythm of the sequence of arched openings, with fences made of wood and glass (FUNALFA, 2015).

Figure 2: Bernardo Mascarenhas Cultural Centre (BMCC).

The structure of the building has received great attention during the process of restoration, which occurred in the 1990's, after its collapse. The external facade of the factory apparently appeared to be in good condition, but, internally, it was in ruins and modifications were needed to recover it (PEREIRA, 2013). The positive point in the restoring was employment the steel as the main material, since it is a recyclable, distinguishable and of easy reversibility material, that one of the better meets the demands of a sustainable work. Table 1 shows the clarifications about the survey that has been conducted.

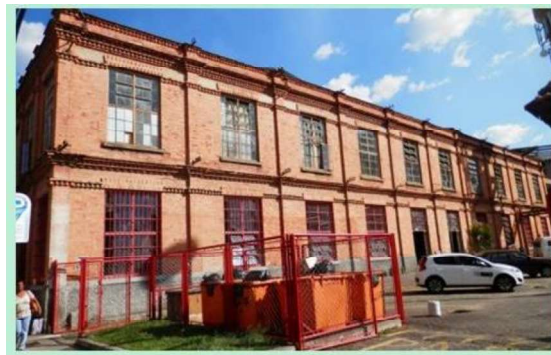
Figure 3: Municipal Market and the Municipal Secretary of Education.

The regularity of the building is marked by the large windows entirely torn, with straight lintels, metal finishing and occlusion made with glass, having security bars in the entire ground floor.

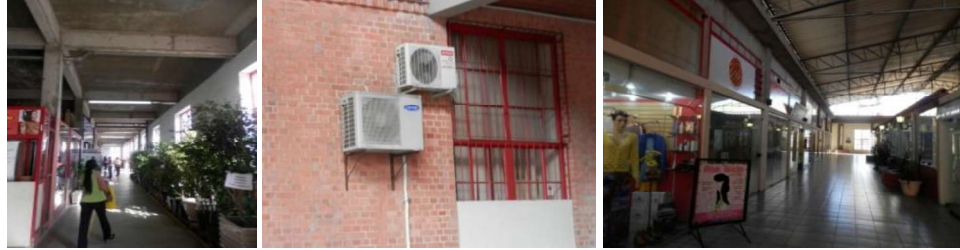
Figure 4: Ground Floor of the Municipal Market, with windows and a circulation corridor, improvised thermal conditioners installed on the facade of the building, facilities for sales stands of concrete and masonry, with a roof of metal structure, hollow elements and systems of air exchange.

Table 2 shows the clarifications about the survey that has been conducted. It was put in evidence in the survey the employment of the internal steel structure of support. Besides the masonry of solid bricks, it were also adopted in the reconstruction some characteristics that allow the adaptation of the space to the new proposed utilizations, such as double height ceilings, ceiling vents and ceiling atrium for smoke exhaust and, finally, the construction of stairs for safer access.

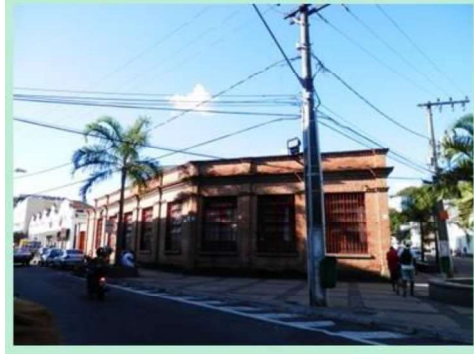
The CEM (Dr. Geraldo Moutinho Centre of Education of Youth and Adults) is a municipal school located in the “extension” of the Mascarenhas Factory (see Figures 1, 5 and 6 and Table 3). It is a ground floor building that has a double height ceiling highlighted by the crowning in the shape of fascia, following the same constructive guidance with apparent solid bricks and ornamentations in the upper entablature arranged in zigzag, with indentations and protrusions; its main facades are composed by rims of windows with small window sills that extend to the ceiling of the building, being the windows also characterized by the iron bars that make the security of the entire complex.

Figure 5: Dr. Geraldo Moutinho Centre of Education of Youth and Adults (CEM).

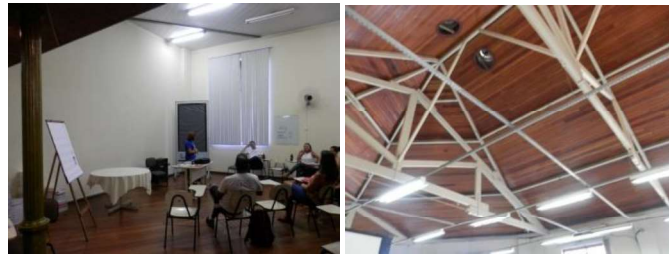
Figure 6: Teacher training centre, sign language class, opening on the second floor to the air vents. Air conditioning is provided in the reconstruction of the building.

The environments are composed by large multifunctional areas, which emphasize the plurality of utilizations of the building, such as workshops, classrooms, spaces reserved for the administrative services and for the administration. The double height ceiling helps with the dispersion of the heat, along with the openings of the shed, producing the exchange of air in the inner environments.

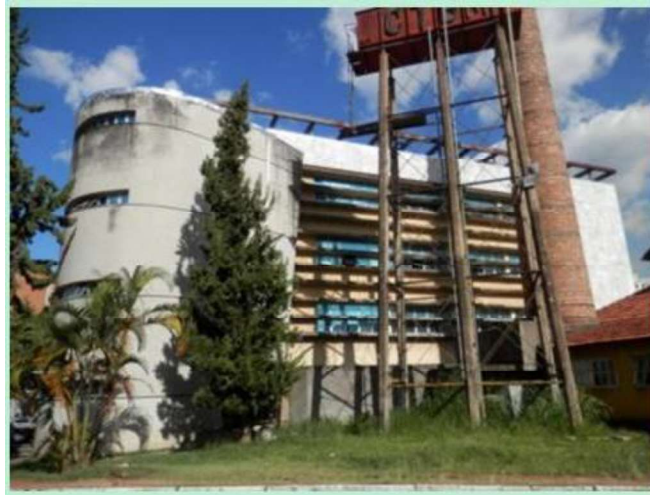
A building with three floors and an area that totalizes 2104 yards square, the library was built by the City Hall of Juiz de Fora in partnership with the Ministry of Culture. It is divided into five sectors, namely the memory sectors, Braille, loans, periodicals, children's and reference sector, with a collection of about 80,000 volumes (FUNALFA 2016). It was inaugurated in 1996 and was designed to facilitate the transit of people with special needs (see Figures 1 and 7).

Figure 7: Murilo Mendes Municipal Library.

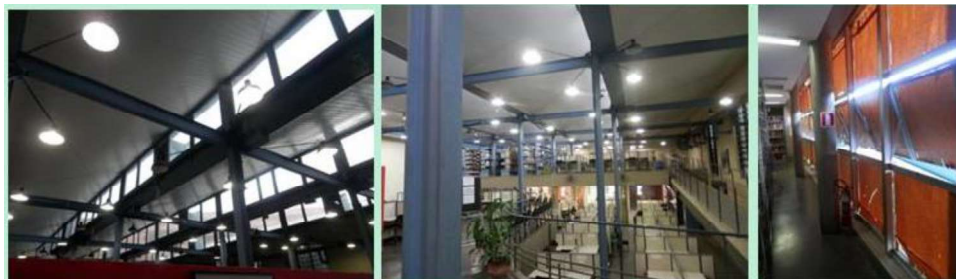
In accordance with the recommendations of Conarq (2011), one of the main functions of the archive is the protection of its collection. The choice of the construction materials, of the finishing and of the equipments must obey to strict safety specifications in order to prevent accidents, environmental or biological aggression, and ensure a good conservation. The materials found in the building are associated with the techniques of precast and with metallic structures, which allow them to be reused, being this a positive aspect of the building. Through photographic survey, it can be seen that these materials preserve their good quality and durability, besides having great resistance to heavy loads, as illustrated in Figure 8 and Table 4.

Figure 8: Interior of the Murilo Mendes Library. 2016.
