Proposal of a Social Index for Sidewalk Quality in Large Brazilian Cities

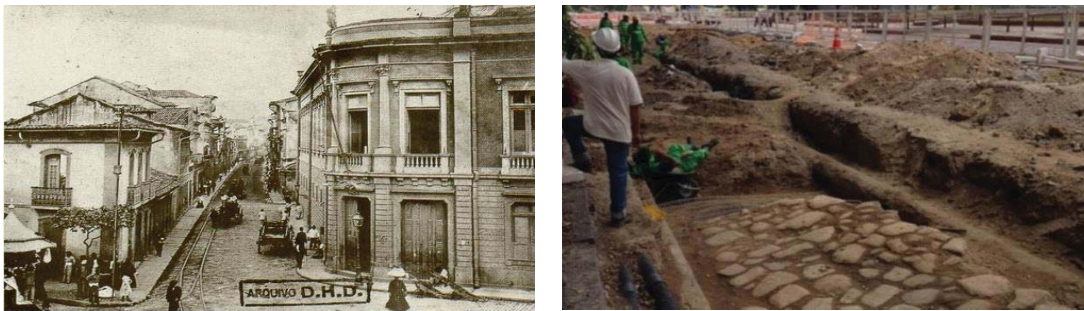
Figure 1. (Left) - Ajuda street at the beginning of the 20th century with sidewalks in granite stones; (right) - Stone sidewalk in "pé-de-moleque" style on Rio Branco avenue, Rio de Janeiro.

Pavements for pedestrians were object of attention of government since the 17th century, when cities still had no motor vehicles. In the city of Rio de Janeiro, capital of the Brazilian empire, "in 1870, a new urban structure was in process, in total harmony with transportation; the city expanded due to the capacity of the transport network to ensure transportation of the population" (Silva, 2008). Figure 1 exhibits the granite sidewalks of Ajuda street, in the proximities of the municipal theater of Rio de Janeiro, in the early 20th century. They offered good comfort and safety conditions even for current demand levels. This example represents a significant advancement in pedestrian infrastructure in comparison to pavements that still prevailed at the time, as the "pé-de-moleque" (boy's-foot, a Brazilian candy made with crunched peanuts) that emerged in colonial times, still present in neighborhoods of Rio de Janeiro and other historical cities of Brazil. Figure 1 also shows a segment in "pé de moleque" on the current Rio Branco avenue, discovered in 2015 upon construction of the light rail vehicle (VLT).

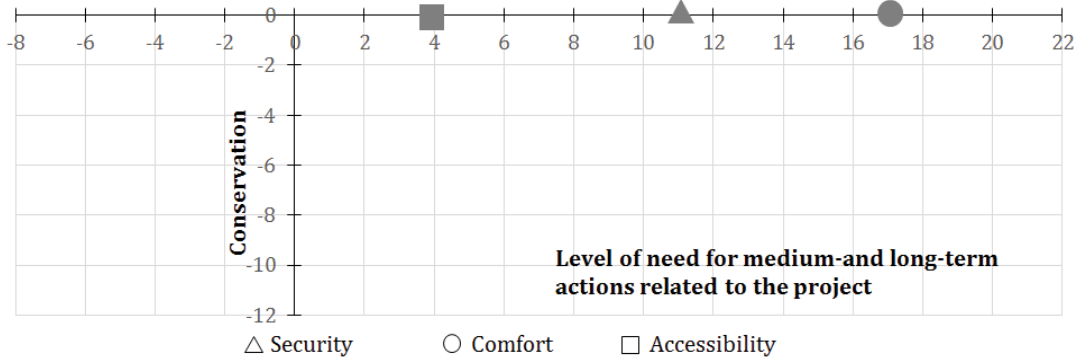
Figure 3. Criteria levels for set up of the sidewalk project for Pasteur avenue, Urca, Rio de Janeiro
 Source: Own authorship.

These partial results are plotted onto the graph in Figure 3, with the score on conservation marked on the axis of ordinates, indicating the degree of urgency for conservation interventions, and the total score of each criterion in the abscissa axis, indicating the level of need for medium and long term actions related to the project.

The final result for SQSI indicates that the assessed sidewalk is overall in good conditions. Nonetheless, the analysis of each portion of equation 2 reveals that the level of project design in relation to safety criteria (0.47) is inferior to others, while the sidewalk project for Pasteur avenue received close attention in terms of comfort (0.93).
